Manhole Inspection Summary

Manhole # S27CC_031MH

Insp Date: **7/3/08 3:51 PM**

Location Address: **649 W LAFAYETTE ST**

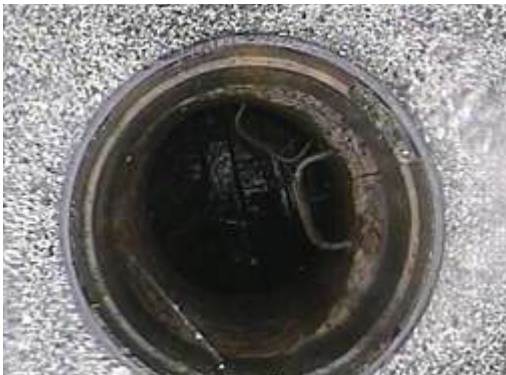
Defect 3

Offset: **2** (in.)

FRAME OFFSET

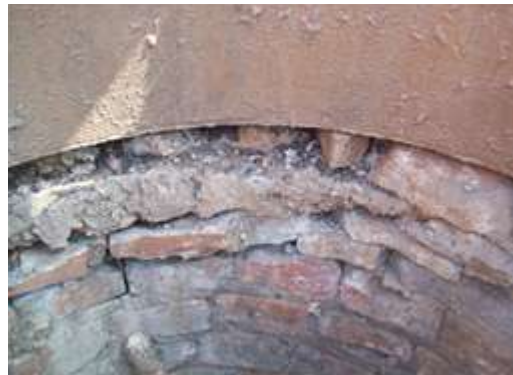
Defect 3

Condition: ☐ Sound ☒ **Cracked** ☐ Root Intrusion ☒ **Loose Brick** ☒ **Deteriorated**

LOOSE BRICKS/ CRACKS

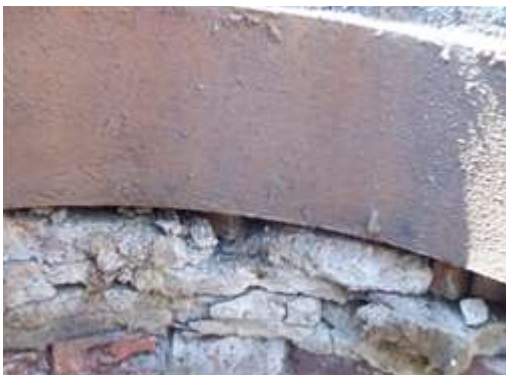
Defect 2

DETERIORATED CHIMNEY

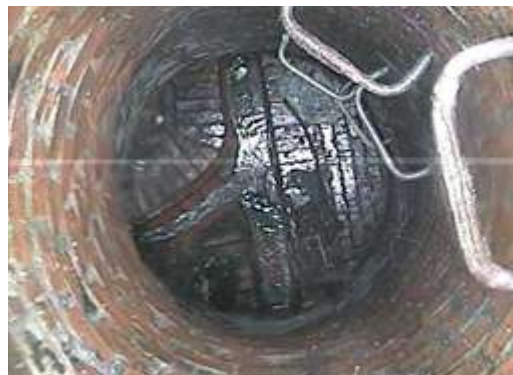
Defect 4

Count: **5** Missing: **0** ☒ **Corroded**

STEPS CORRODED

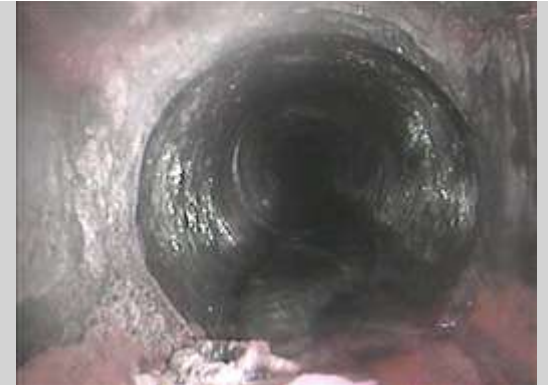
12 O'Clock Outflow

8 in. Circular Gravity Sewer
Pipe Out @ 12 O'Clock

Pipe Material: **Clay** ☐ Pipe Lined

Invert Depth: **9.20** (ft.) Flow Characteristics: **Slow**

Infiltration: **None** Pipe Seal Cond: **Sound**

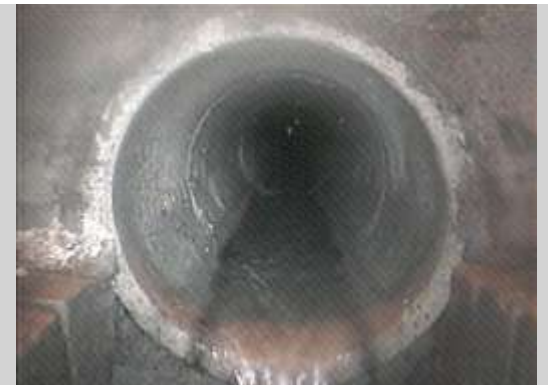
6 O'Clock Inflow

8 in. Circular Gravity Sewer
Pipe In @ 6 O'Clock

Pipe Material: **Clay** ☐ Pipe Lined

Invert Depth: **9.19** (ft.) Flow Characteristics: **Slow**

Infiltration: **None** Pipe Seal Cond: **Sound**

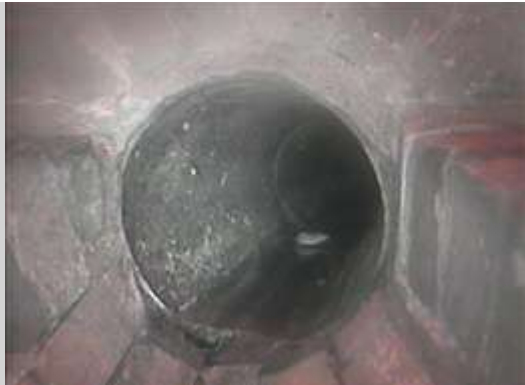
9 O'Clock Inflow

8 in. Circular Gravity Sewer

Pipe In @ 9 O'Clock

Pipe Material: **Clay** ☐ Pipe Lined

Invert Depth: **9.01** (ft.) Flow Characteristics: **Slow**

Infiltration: **None** Pipe Seal Cond: **Sound**
